Flood Control Project Maintenance
2011 Structure Summary Report
Overall Unit and Item Ratings

Madera County FCWCA

Ash And Berenda Slough Control Structures

Fresno River Diversion Weir

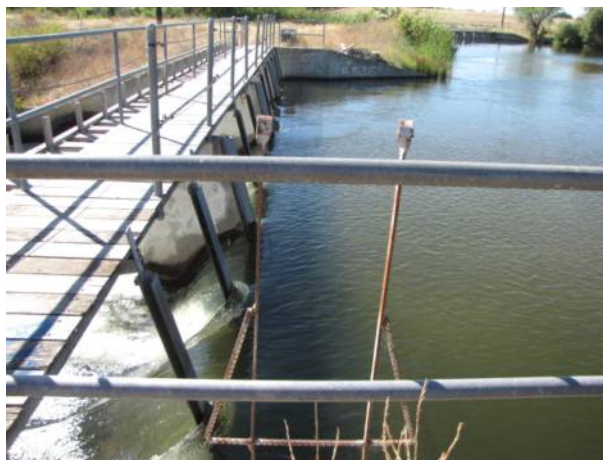
phillips_t_20110906_013.jpg

Berenda Slough Control Structure standing on the upstream side of structure. Photo taken 7-12-2011

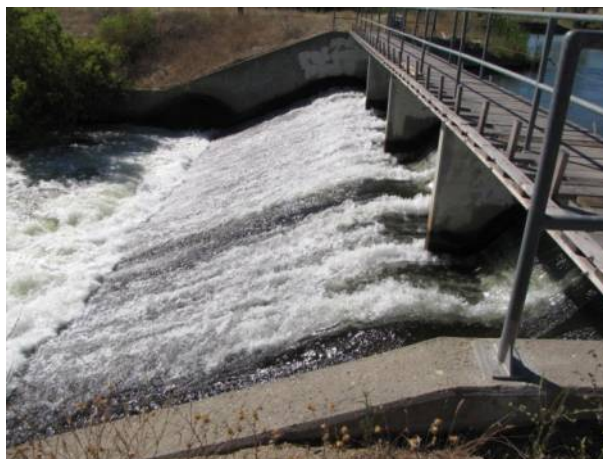
phillips_t_20110906_014.jpg

Berenda Slough Looking at the downstream side of Structure. Photo taken 7-12-2011.

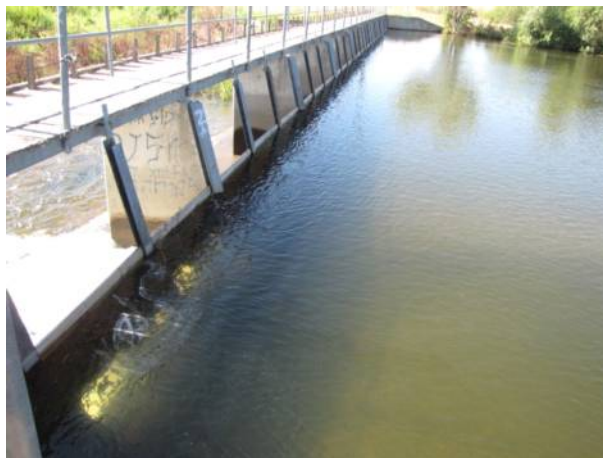
phillips_t_20110906_015.jpg

Ash Slough Control Structure standing on upstream side of structure. 37.143520 - 120.162171

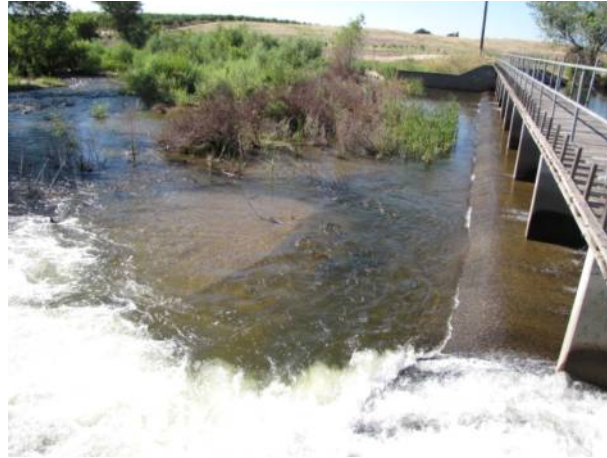
phillips_t_20110906_016.jpg

Ash Slough Control Structure looking at the downstream side of structure. Photo taken 7-12-2011

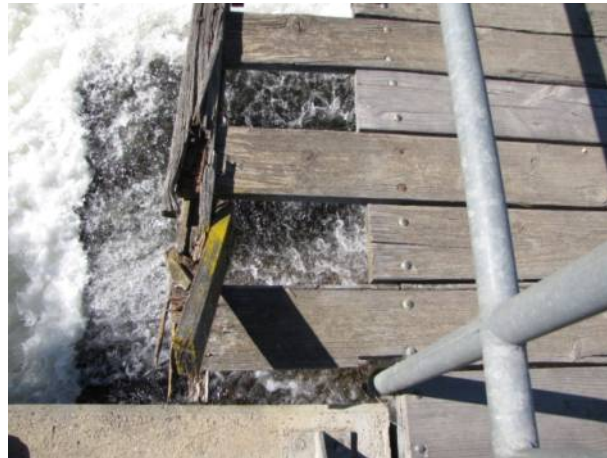
phillips_t_20110906_017.jpg

22	0.00	0.00	Structures	Monolith Joints		N	Inspector Comments: This item does not apply to this inspection.	37.157904 ° -120.124165 °	37.143520 ° -120.162171 °	22
23	0.00	0.00	Structures	Safety		M	Inspector Comments: Minor safety hazards are present, but do not pose an immediate threat to the structure or personnel at the structure. Corrections should be made prior to the next annual inspection. 37.143520 - 120.162171	37.157904 ° -120.124165 °	37.143520 ° -120.162171 °	23 Y

Ash Slough Control Structure show some damage timbers along the cross walk.

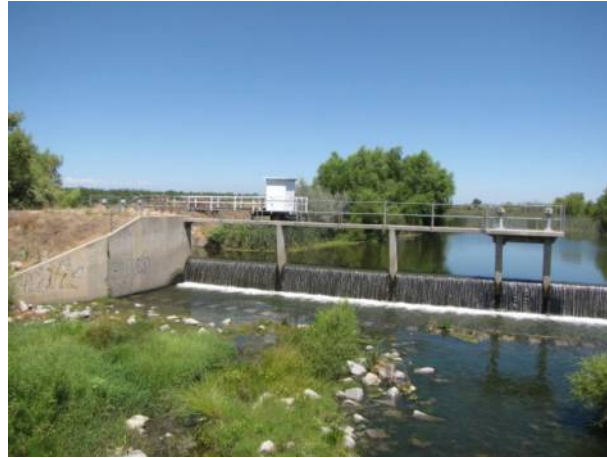
phillips_t_20110901_001.jpg

Fresno River Diversion Weir viewed from Rd. 16 bridge crossing, looking back upstream towards the unit 5 right bank levee. Photo taken 7-12-2011.

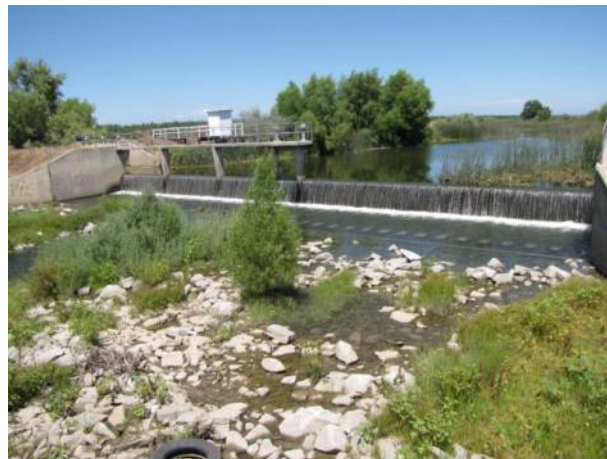
phillips_t_20110902_007.jpg

LMR No.	Levee Mile		Category	Item	Location *	Rating **	Action/Comment	GPS Latitude/Longitude		Issue No.
	Start	End						Start	End	Photo
1	0.00	0.00	Structures	Photo Documentation				36.967930 ° -120.255680 °	36.967930 ° -120.255680 °	1 Y
2	0.00	0.00	Structures	Vegetation & Obstructions		M	Inspector Comments: There is a build up of vegetation on the downstream side of the deflectors within the channel of the Fresno River and on the left bank (unit 6) there is buildup of veg. growth inside the security fence area on the bank.	36.967930 ° -120.255680 °	36.967930 ° -120.255680 °	2 Y
3	0.00	0.00	Structures	Shoaling / Sedimentation		A	Inspector Comments: No shoaling or sedimentation present.	36.967930 ° -120.255680 °	36.967930 ° -120.255680 °	3
4	0.00	0.00	Structures	Erosion / Bank Caving		A	Inspector Comments: There was no presence of erosion at this structure during my inspection 7-12-2011	36.967930 ° -120.255680 °	36.967930 ° -120.255680 °	4

This photo here shows the vegetation build up near the weir deflectors, there is some tulies developing on the upstream side left bank of the structure that need to be removed.
